# Manhole Inspection Summary

Manhole # S11GG\_037MH

Insp Date: 1/21/09 9:12 AM

**Location** Address: **3121 PRESBURY ST**

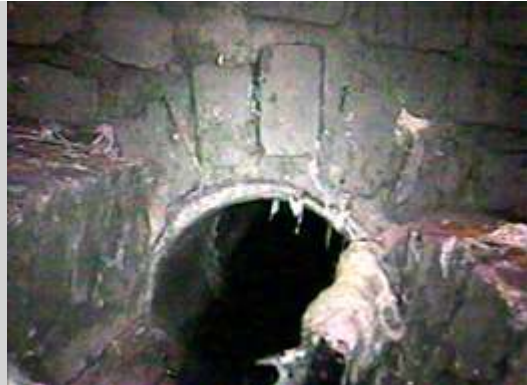
12 O'Clock Outflow

8 in. Circular Gravity Sewer  
Pipe Out @ 12 O'Clock

Infiltration: **None** Pipe Seal Cond: **Sound**
